Solar Installation Inspection Report

21 Summerhayes Drive, Karrinyup WA 6018

Inspection Date:
18th March 2026

Prepared by:
West Vector Aerial

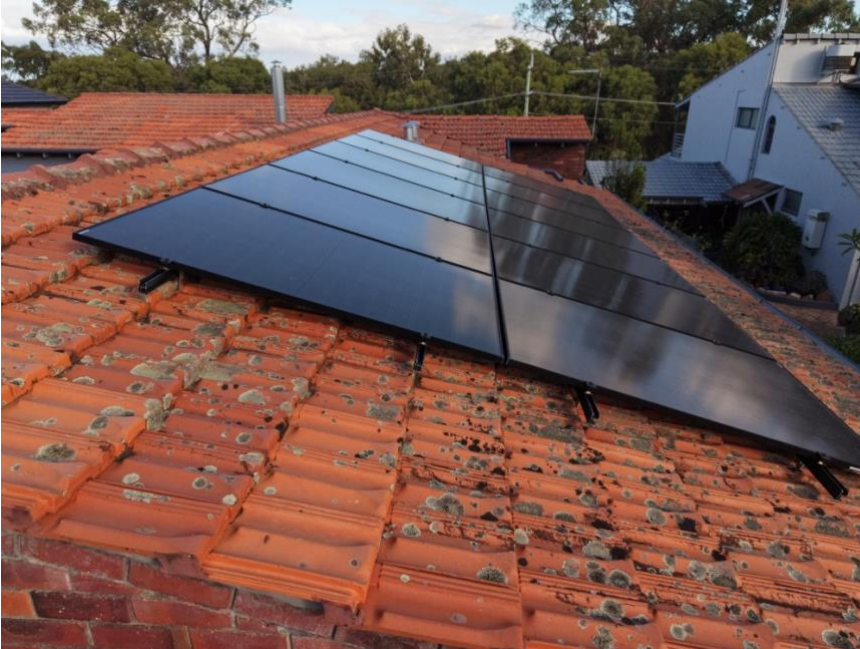
Figure 1.1 – Oblique View - West

Panel plane appears consistent with no visible lifting or distortion.

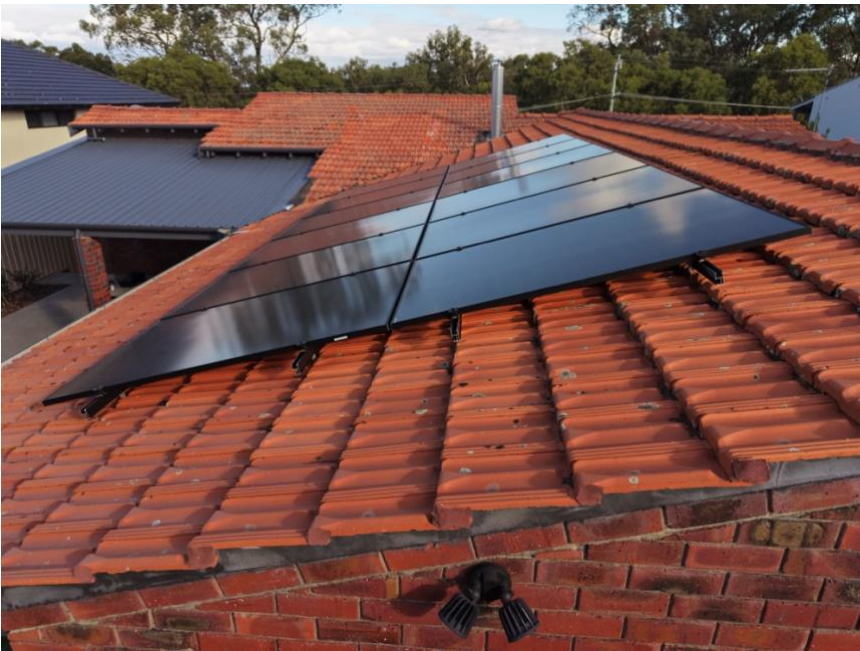
Figure 1.2 – Oblique View - East

Panel plane appears consistent with no visible lifting or distortion.

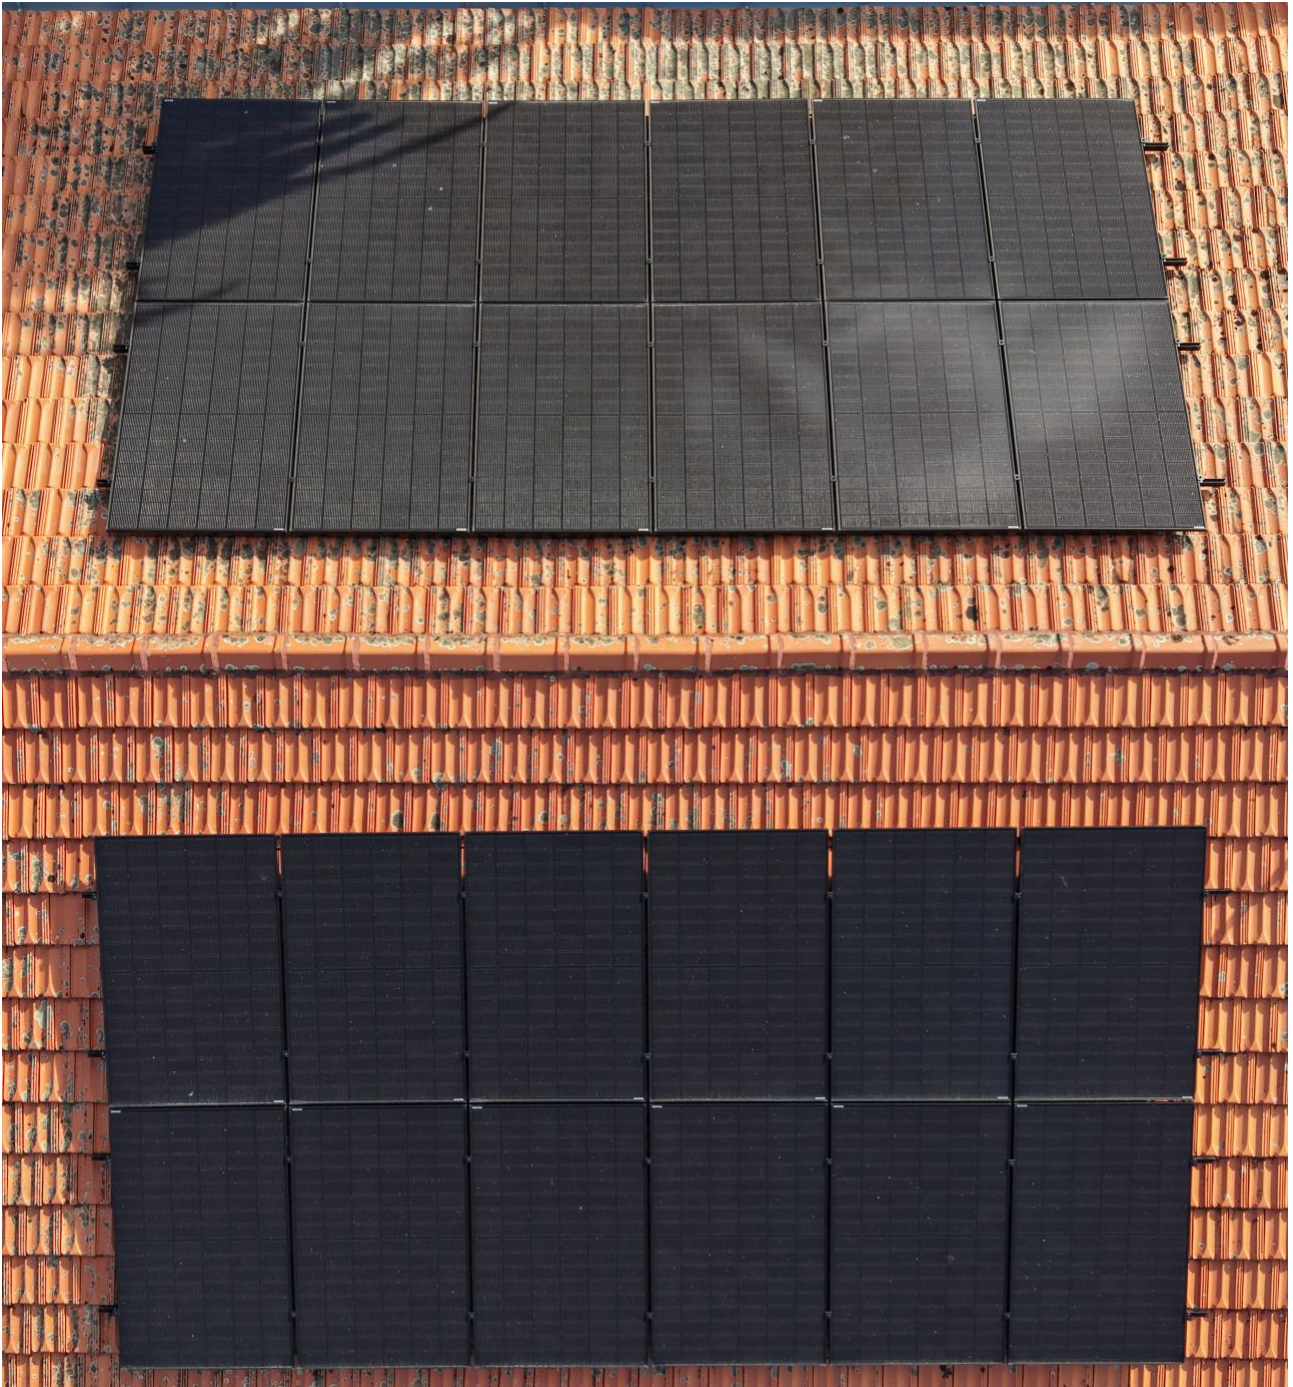
Figure 1.3 – Roof Overview

Installation appears symmetrical and well integrated with roof geometry.
