**Drone Roof Inspection Report**  
1/29 Ramsdale St, Doubleview WA 6018

**Inspection Date:**  
15 March 2026

**Prepared by:**  
West Vector Aerial

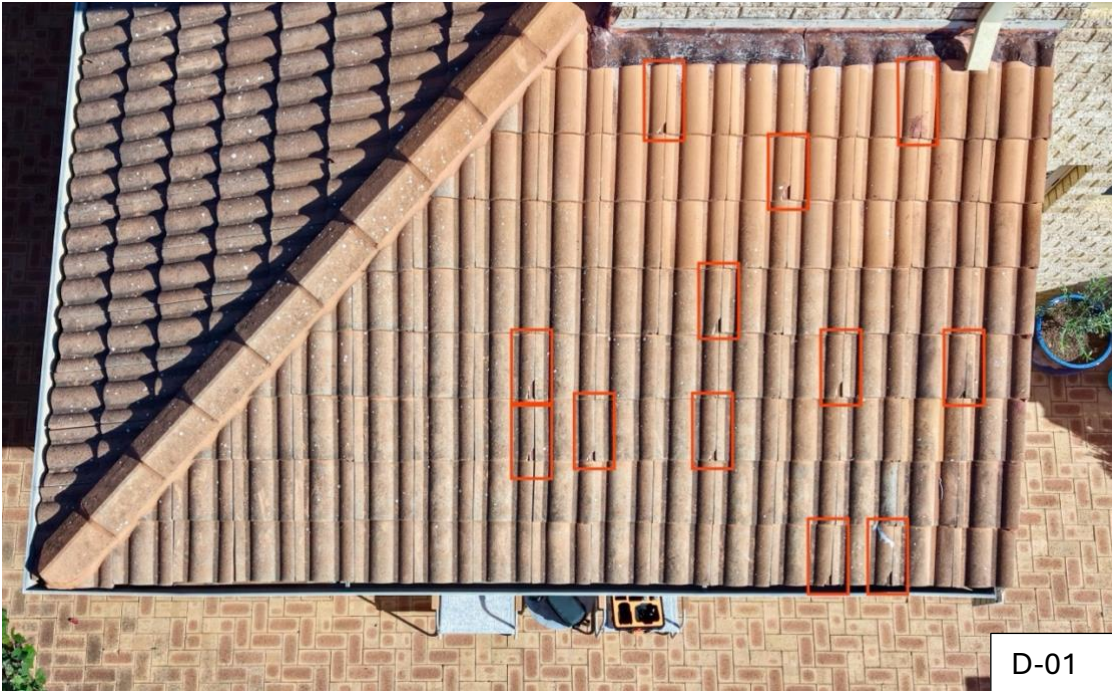
### Ground Floor – North

Image 1.1 – Localised tile chipping (D-01)

**Description:** Approximately 65 roof tiles exhibit minor surface chipping and cosmetic wear. No evidence of structural cracking or water ingress was observed.

**Severity:** Minor

**Recommendation:** Monitor during routine roof maintenance. Replacement not immediately required.

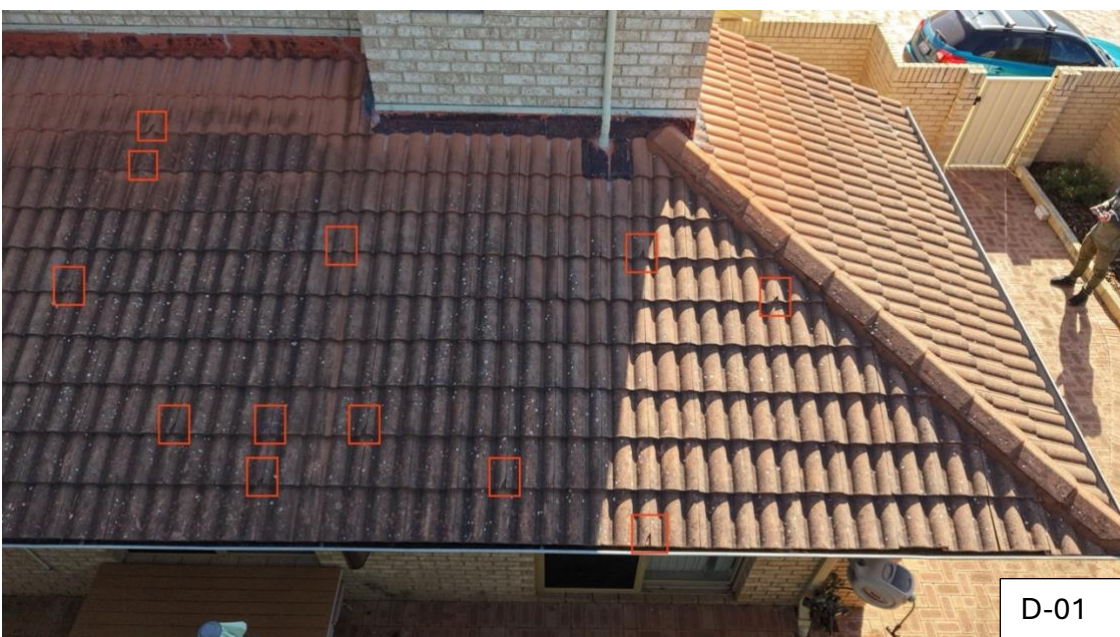
### Ground Floor – East

Image 1.2 – Localised tile chipping (D-01)

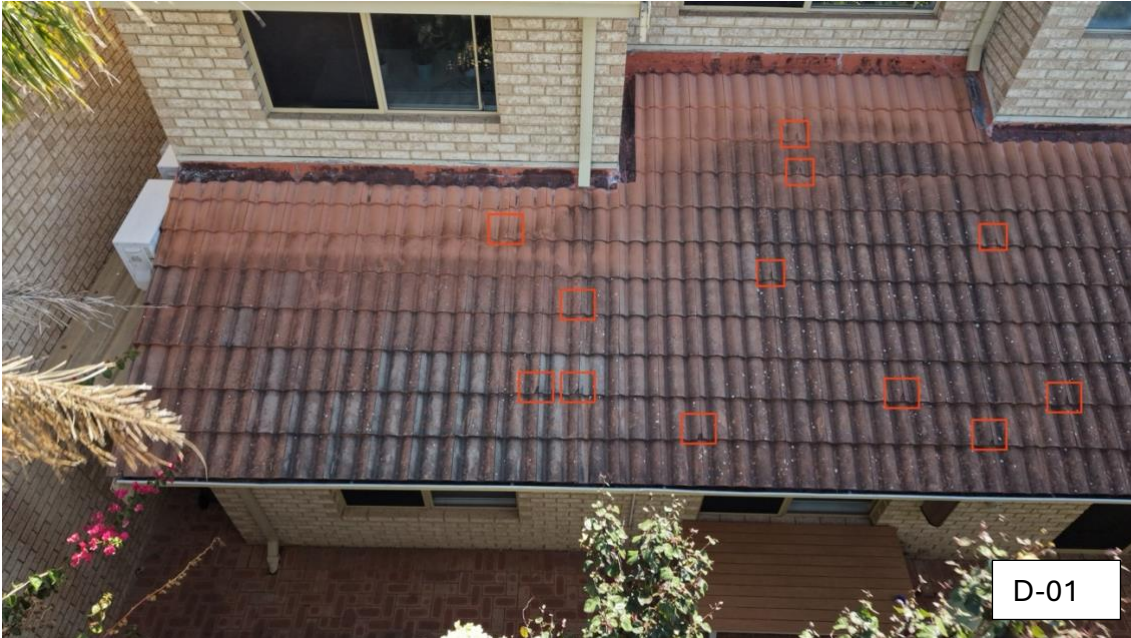
## Ground Floor – East

*Image 1.3 – Localised tile chipping (D-01)*

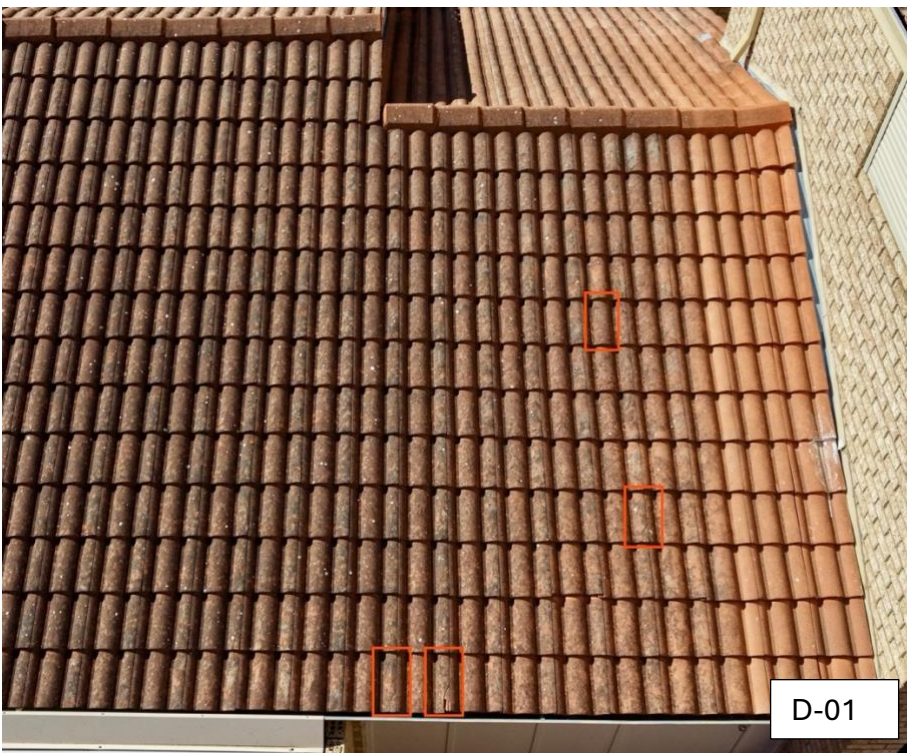
## Ground Level Garage – South

*Image 1.4 – Localised tile chipping (D-01)*

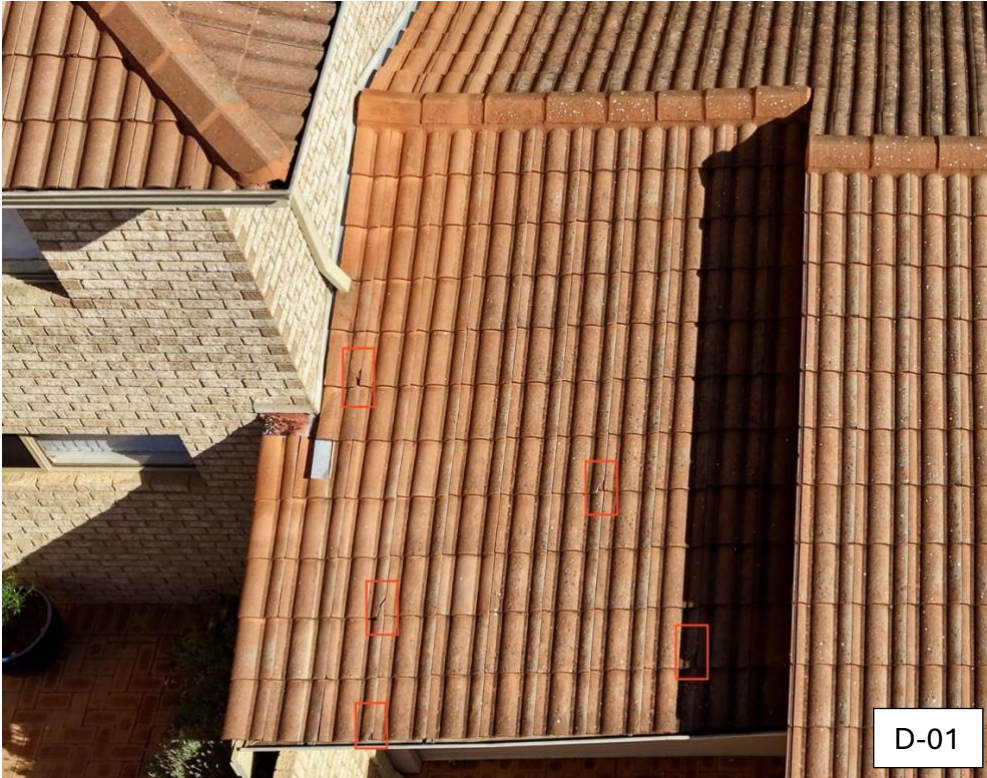
### Ground Level Garage – North

*Image 1.5 – Localised tile chipping (D-01)*

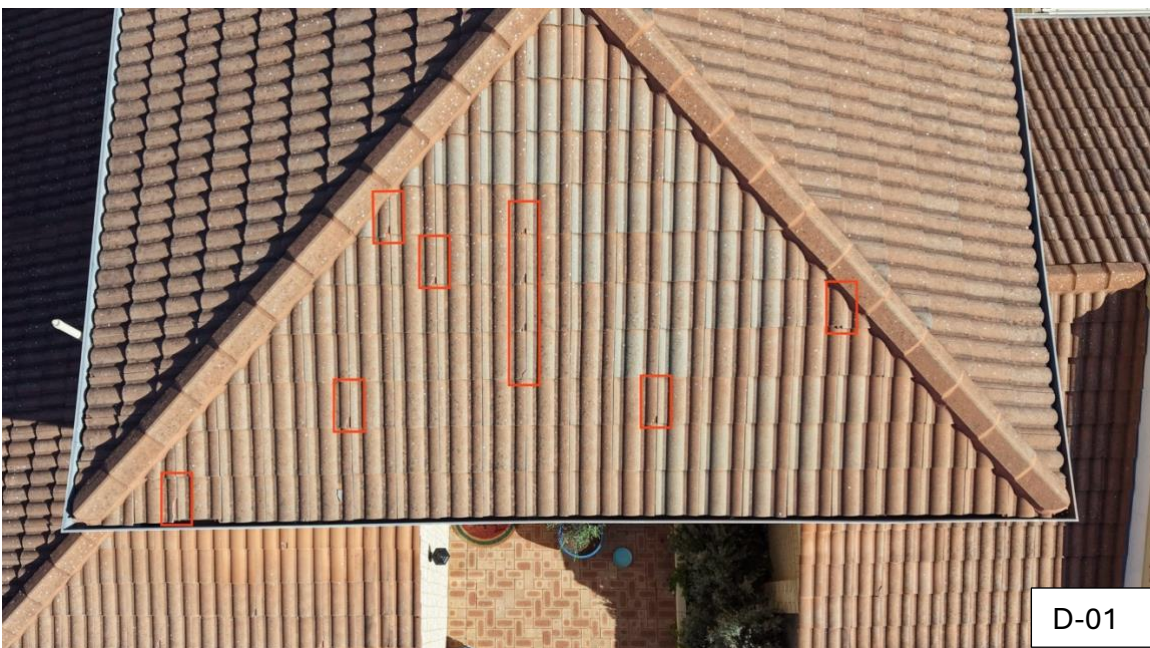
### 2<sup>nd</sup> Storey – North

*Image 1.6 – Localised tile chipping (D-01)*

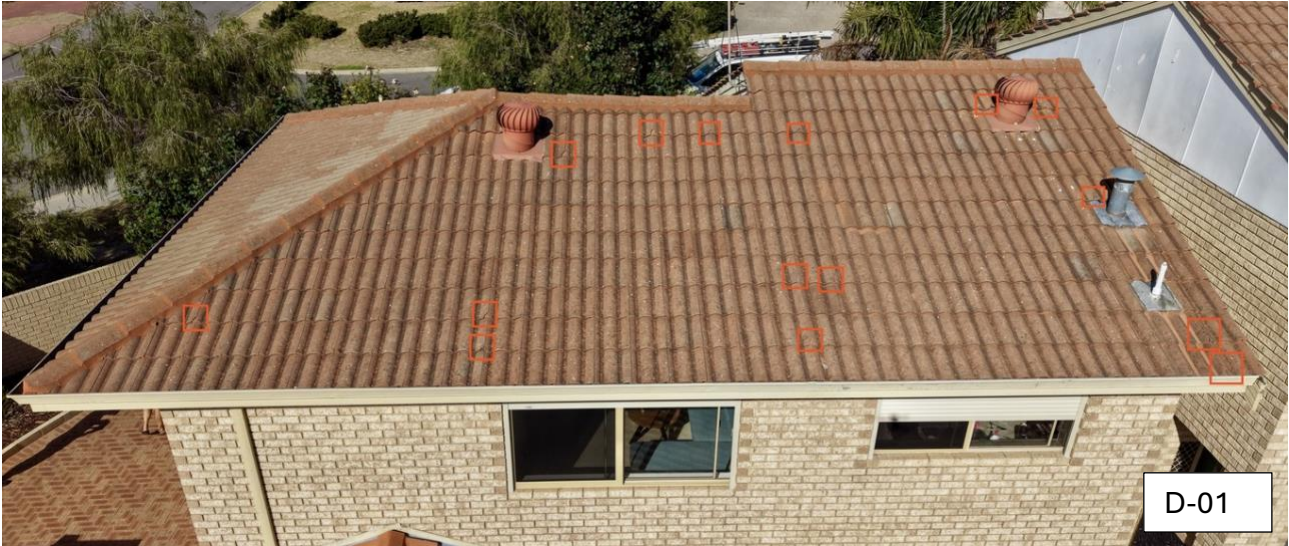
## 2<sup>nd</sup> Storey – West

*Image 1.7 – Localised tile chipping (D-01)*

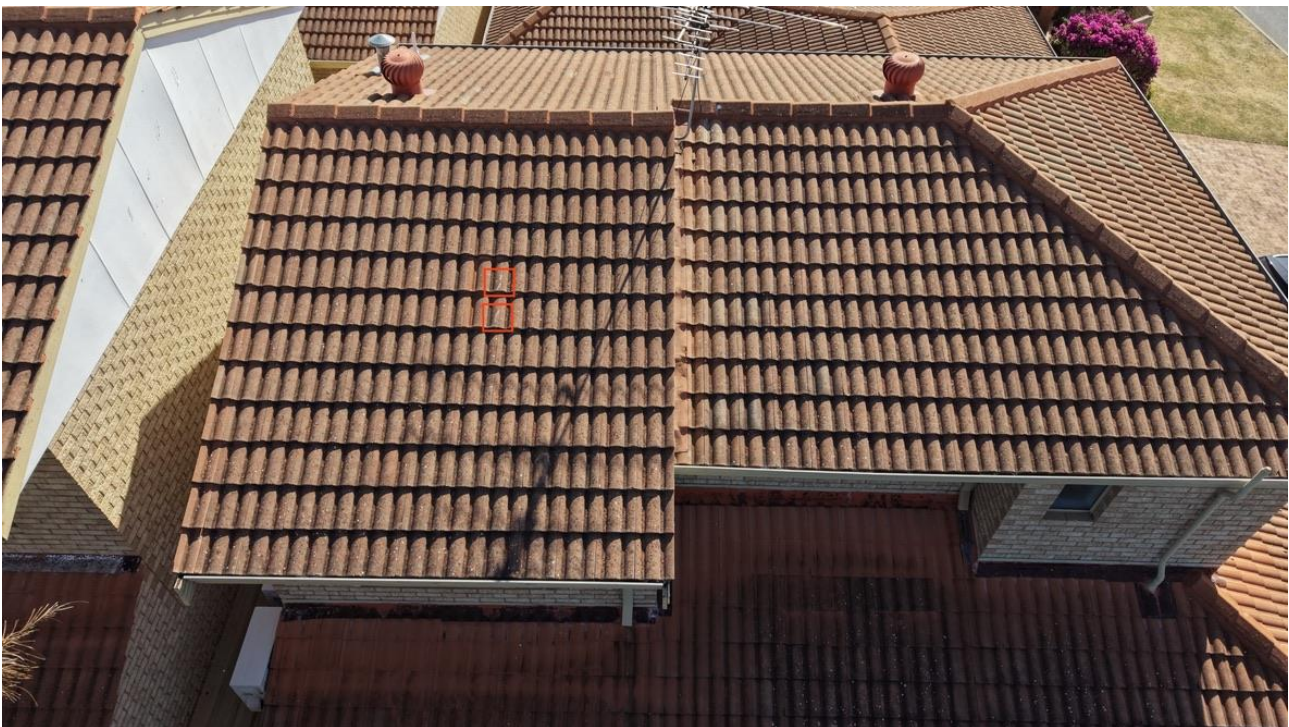
## 2<sup>nd</sup> Storey – East

*Image 1.8 – Localised tile chipping (D-01)*

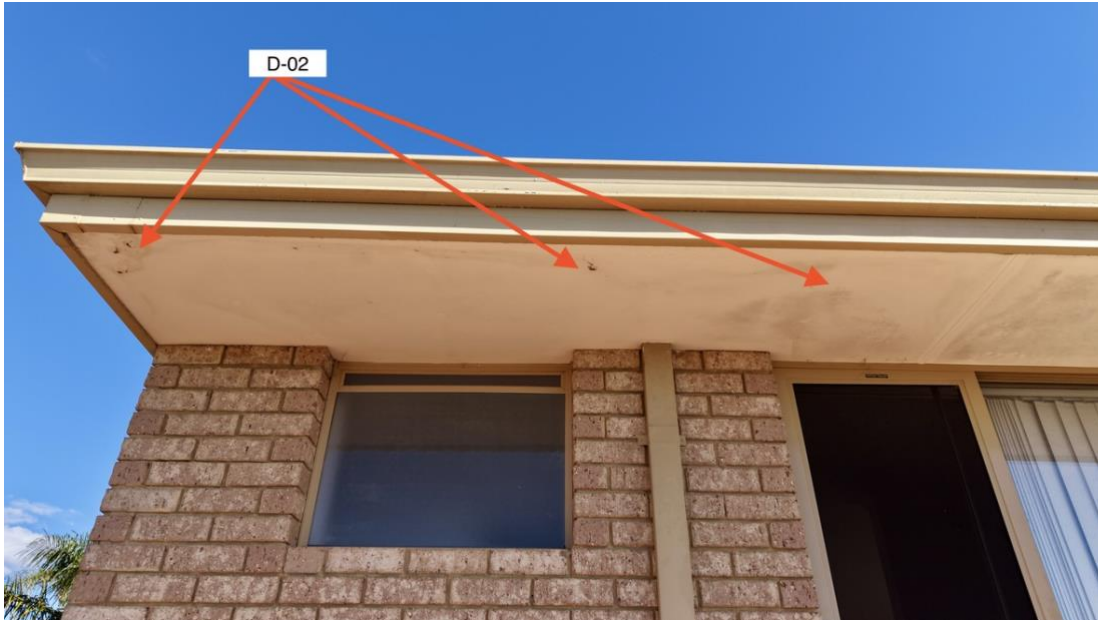
## 2<sup>nd</sup> Storey – North

*Image 2.1 – Water ingress – eaves (D-02)*

**Description:** Evidence of water ingress observed to the eaves lining, including staining and material deterioration. May be associated with roof flashing, guttering, or junction detailing above.

**Severity:** Moderate

**Recommendation:** Engage a qualified roofing contractor to inspect roof flashings, gutters, and junctions. Further assessment is recommended to identify any ingress points. Maintenance or repair works may be required depending on findings.

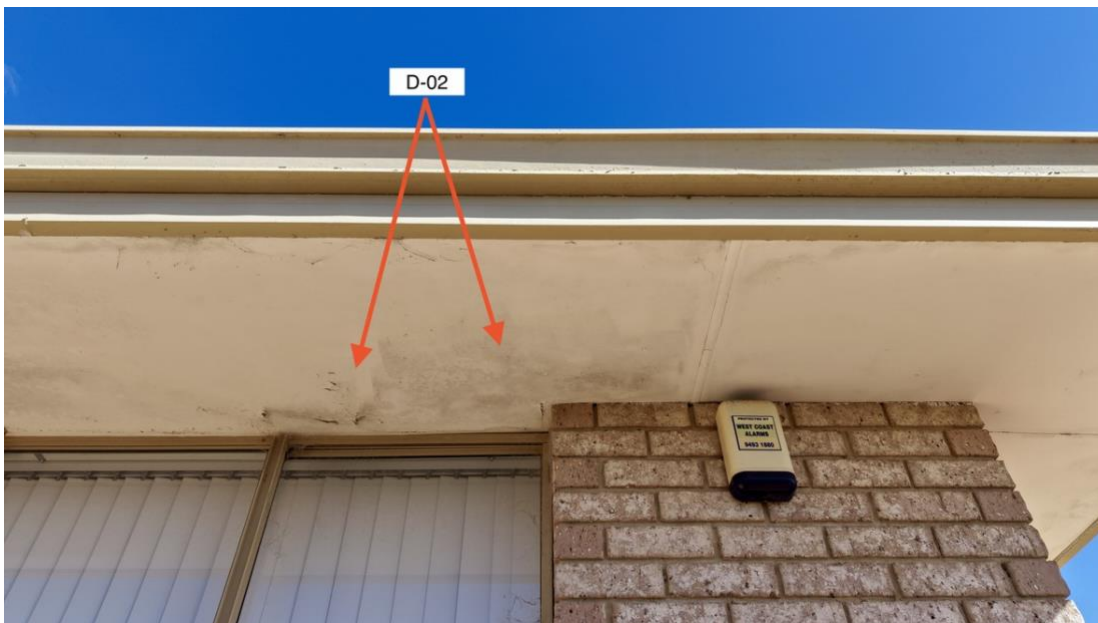
*Image 2.2 – Water ingress – eaves (D-02)*
